Site performance of galvanic anodes in concrete repairs

Citation: CHRISTODOULOU, C., GOODIER, C.I. and AUSTIN, S.A., 2014. Site performance of galvanic anodes in concrete repairs. IN: Grantham, M, et al (eds). Concrete Solutions 2014. Proceedings of Concrete Solutions, the 5th International Conference on Concrete Repair, 1st-3rd September 2014, Belfast. Boca Raton, Fl: CRC Press, pp. 167-172.

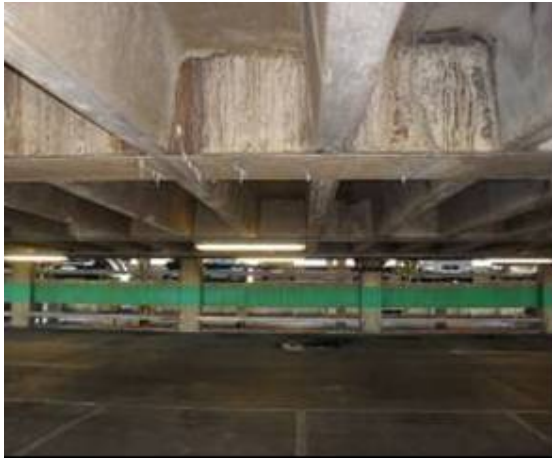
Figure 1. General condition of the MSCP's soffit indicating leaching, dynamic cracking and deterioration of the concrete elements.

A multi-storey car park (MSCP) in the UK suffering from chloride-induced corrosion was selected for this work (Figure 1). The structure was built in the early 1970s with one-way spanning concrete ribbed type deck arrangement.

Intrusive investigations were undertaken in 1997, 1999 and 2008 to determine the extent of chloride contamination whilst also assessing the probability of corrosion activity with potential mapping. The decks and soffits, especially adjacent to the expansion joints, appeared to have high levels of chloride concentration at the depth of reinforcement; hence according to Bridge Advice Note 35 (DMRB 1990) there was a significantly high risk of corrosion. By 2008, there were locations where the chloride levels were up to 2.9% by weight of cement at a depth of 30 to 55 mm, where the reinforcement was located.

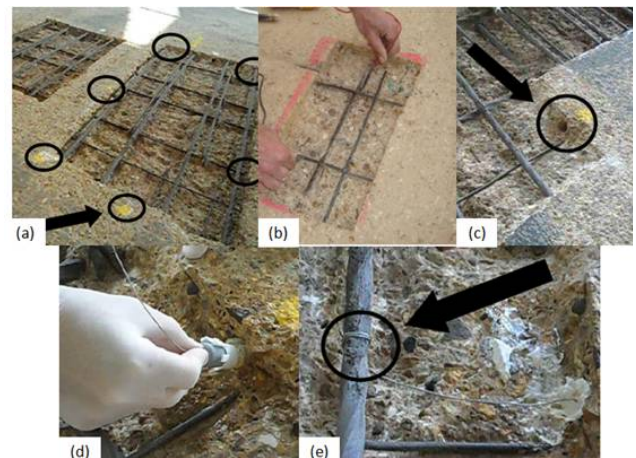
Figure 2. Galvanic anode type A installation procedure, (a) repair area following breakout and with location of anode installation marked out, (b) testing for reinforcement continuity, (c) pre-drilled holes for anode installation, (d) installation of galvanic anode and (e) connection of galvanic anode to the steel reinforcement and anode hole following filling with the proprietary backfill (Christodoulou et al. 2014)

Anodes type A, were installed in pre-drilled holes of 25 mm diameter and 45 mm long in the parent concrete, as close as practically possible to the edge of the patch and then filled with proprietary backfill (Figure 2). A titanium wire integrated with the galvanic anodes made a connection to the steel reinforcement within the repair area. Their installation spacing was 250mm centres.

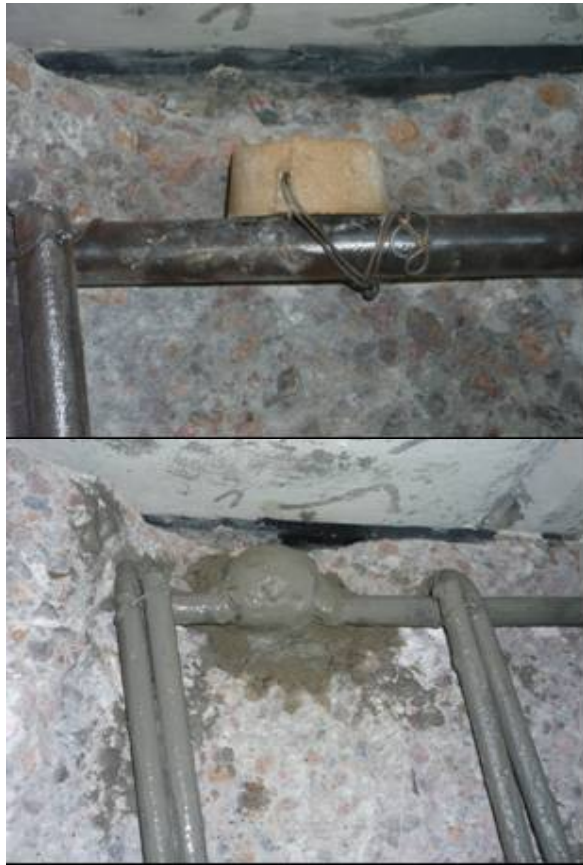
Figure 3. Galvanic anode type B installation procedure, (left) anode tied to the reinforcement as close as practically possible to the edge of the repair and (right) galvanic anode encapsulated in proprietary embedment mortar.

Anodes type B were installed within the patch repair on the side of the exposed reinforcement, as closely as possible to the edge of the repair. A steel wire integrated with the galvanic anodes made a connection to the steel reinforcement. The anodes were also encapsulated in a proprietary embedment mortar to provide a conductive path to the substrate (Figure 3). Their installation spacing was 250mm centres.

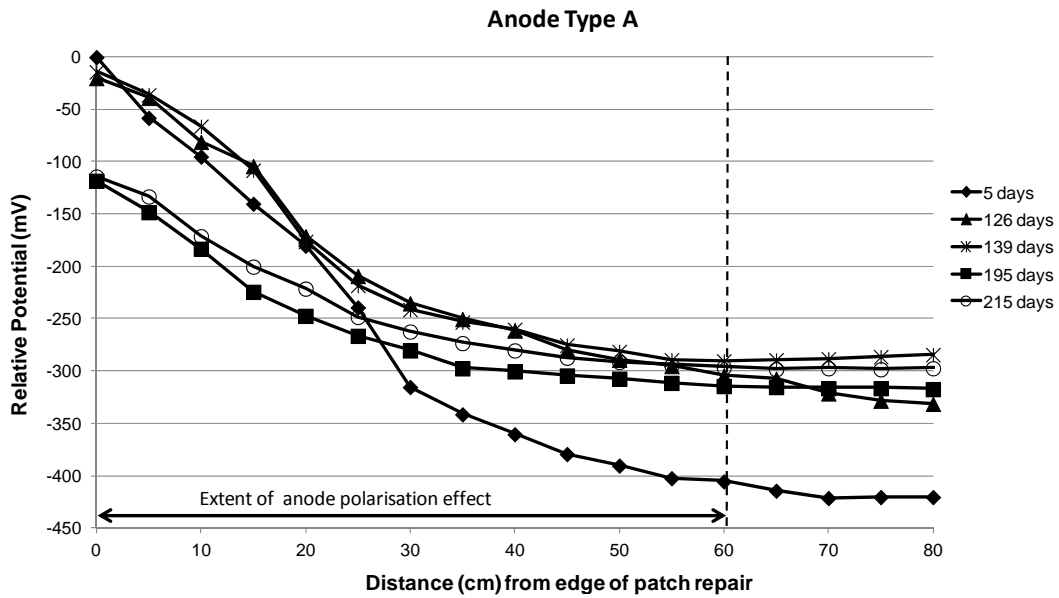
Figure 4. Polarisation effect afforded by anodes type A at a distance from the edge of a patch repair over a period of 215 days.

The typical polarisation effect afforded by anodes type A at a distance away from the edge of the patch repair between 110 and 215 days following installation is shown in Figure 4. It can be observed that the anodes affected the potentials to a distance of approximately 600 mm from the edge of the repair even after 215 days. The time dependant trends observed can be attributed to changes in the weather conditions.

The monitoring data indicated a variance in the performance between anode types A and B. Galvanic anodes type A, installed in the parent concrete around the repair, demonstrated polarisation effects of up to 600mm away from the patch repair itself over a period of 215 days. However galvanic anodes type B, embedded within the patch repair itself, demonstrated limited polarisation effects and in cases none at all over a period of 28 days. Similar observations have also been made by Dugarte and Sagues (2007).

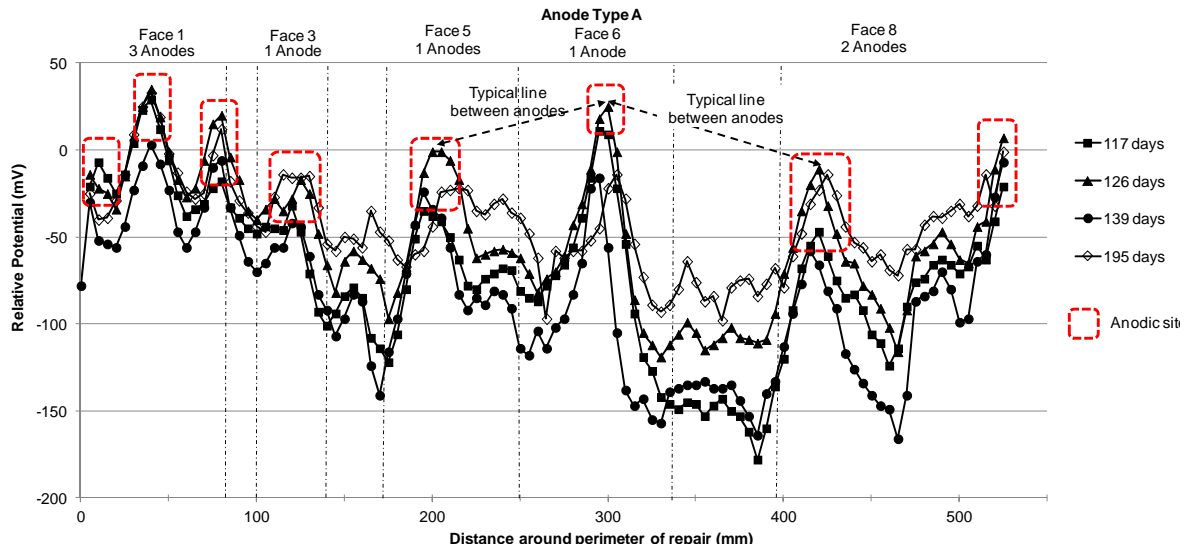
Figure 5. Potential mapping around a patch repair location with anodes type A over a period of 195 days

Figure 5 demonstrates the results of potential mapping around the perimeter of a patch repair with anode type A over a period of 195 days. It can be observed that the anodic points identified in the mapping, coincided at all times with the location of the galvanic anodes (anodic points have been circled). It can be observed that the potentials never rose higher than the imaginary lines connecting the anodic spots, suggesting that there are no other anodic spots between the galvanic anodes.

These results were typical and re-occurring findings through all the patch repairs on this MSCP for the polarisation effect afforded by galvanic anodes type A to steel in parent concrete at a distance from the edge of the patch repair. Readings past 215 days could unfortunately not be obtained, as thereafter the slabs received a surface applied waterproofing coating.

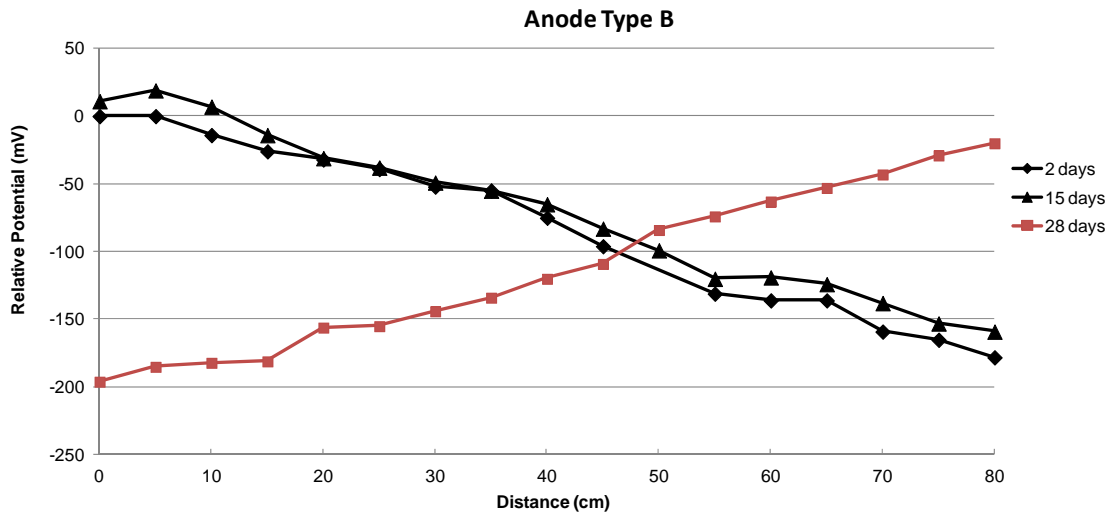
Figure 6. Polarisation effect afforded by anodes type B at a distance from the edge of a patch repair over a period of 28 days.

The typical polarisation effect afforded by anodes type B at a distance away from the edge of the patch repair over a period of 28 days following installation is shown in Figure 6. It can be observed that there was a polarisation effect almost over the entire measurement length of 800mm over the first 15 days. However, at 28 days it was observed that the effect was entirely lost and no polarisation was afforded to the steel in the parent concrete adjacent to the repair.

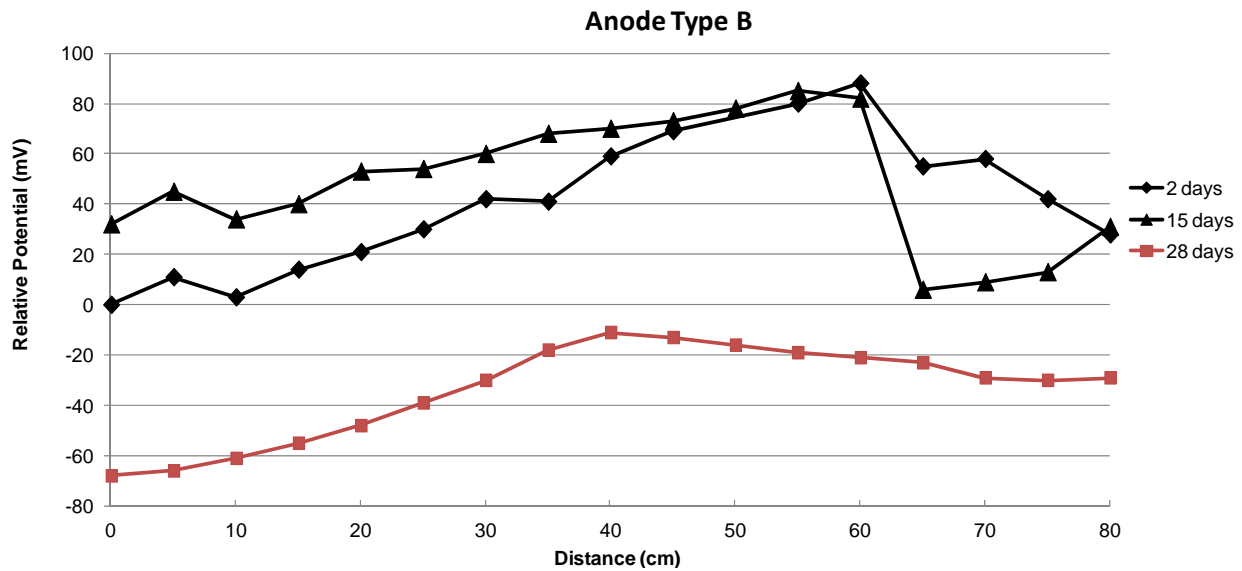
Figure 7. Polarisation effect afforded by anodes type B at a distance from the edge of a patch repair over a period of 28 days.

In a similar repair with type B anodes, potential mapping over a period of 28 days demonstrated that the anodes provided no polarisation effect at all to the reinforcement in the parent concrete adjacent to the patch repair (Figure 7). Unlike the previous repair, this behaviour was experienced from day 2 and throughout the testing. The above, are typical and re-occurring findings for the polarisation effect afforded by galvanic anodes type B to steel in parent concrete at a distance from the edge of the patch repair. Readings over 28 days could not be obtained, as thereafter the local concrete patch repairs received a surface applied waterproofing coating
